## **AIRCRAFT ACCIDENT REPORT NUMBER 2011-003**

**GROUND IMPACT, A CHARTER FLIGHT, ROBINSON HELICOPTER R44 II,  
REGISTRATION 9XR-SI, GATARE SECTOR, NYAMAGABE DISTRICT,  
24 AUGUST 2011**

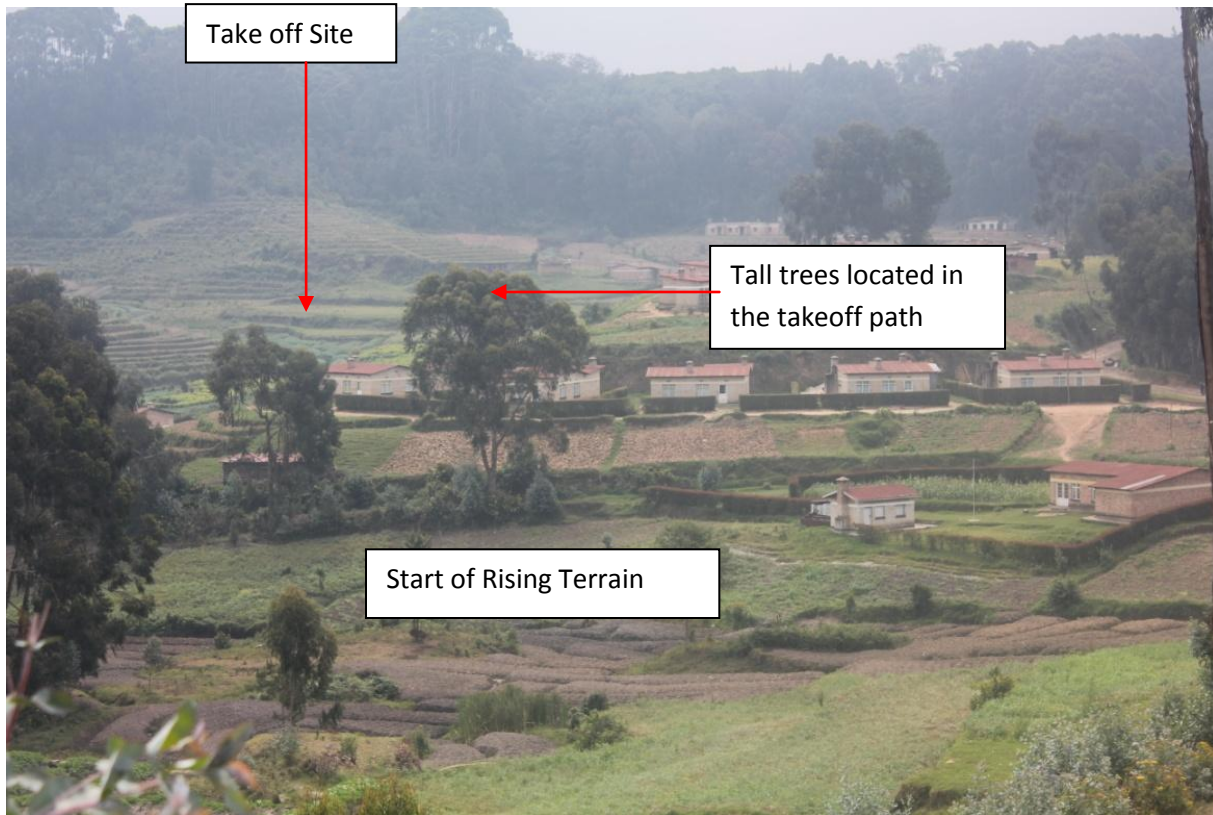
The take off site was a lower ground surrounded by rising terrain and tall trees. The preferred site had a limited open space (about one (1) km) that quickly terminated into a rising terrain.

**Photo 1** showing take off site and available open space (Flight Path)

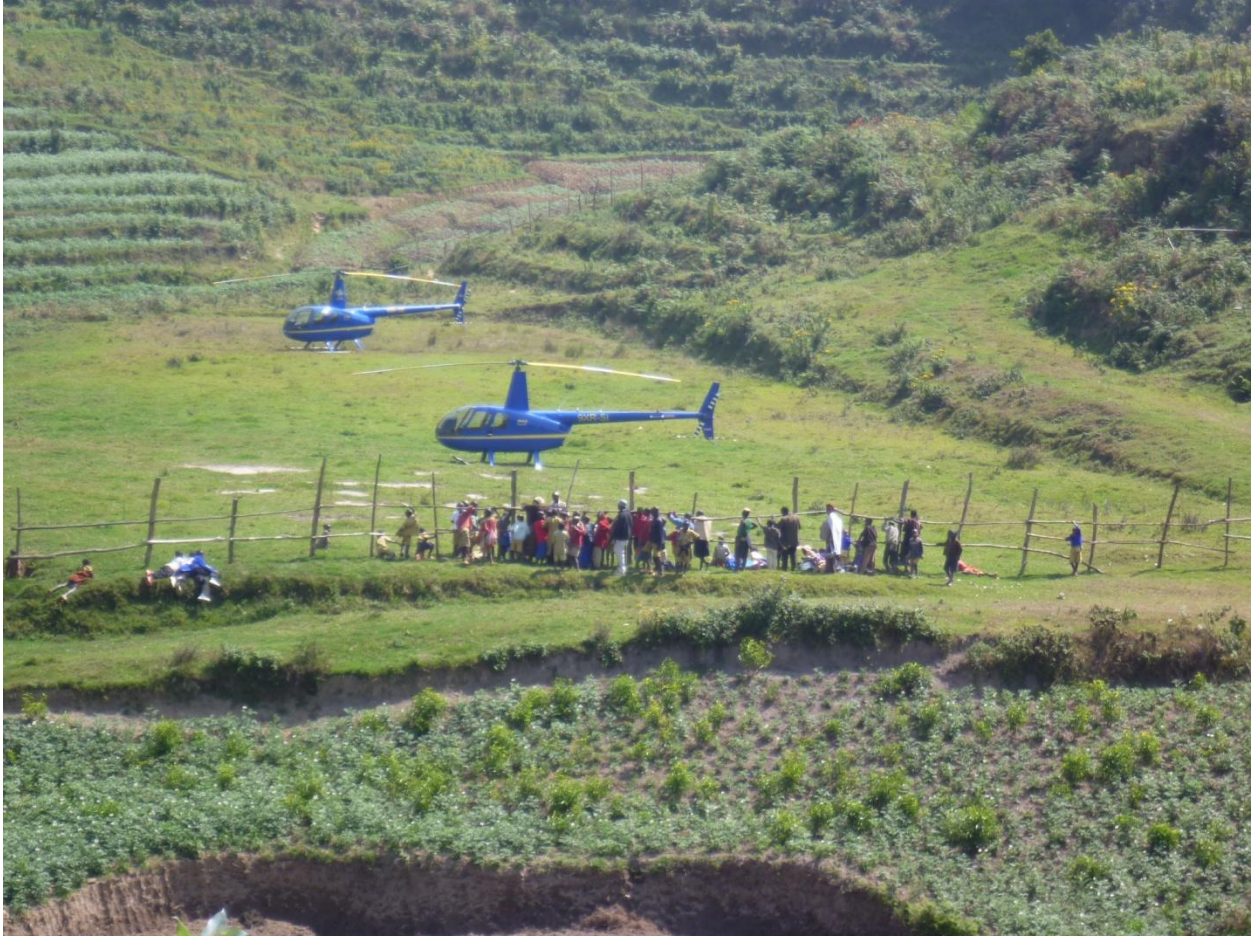
**Photo 2: Take off Site**

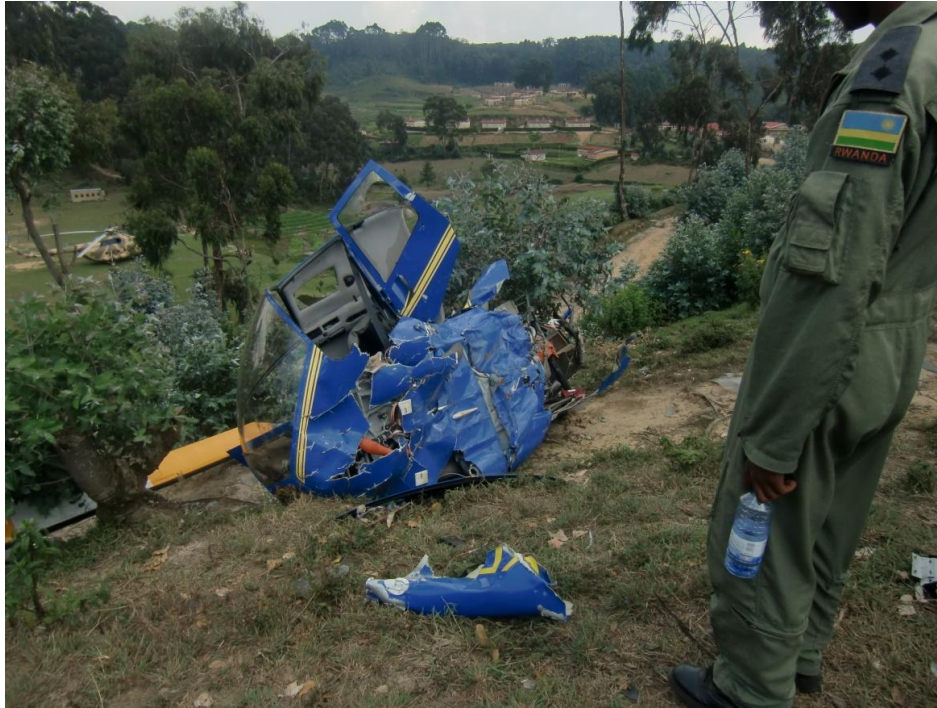
The main wreckage consisting of fuselage, engine, main rotor minus the empennage section, was located midway of the rising terrain flank. The fuselage was positioned with its nose pointing about 095 degrees magnetic.

**Photo 3.** Location of main helicopter wreckage

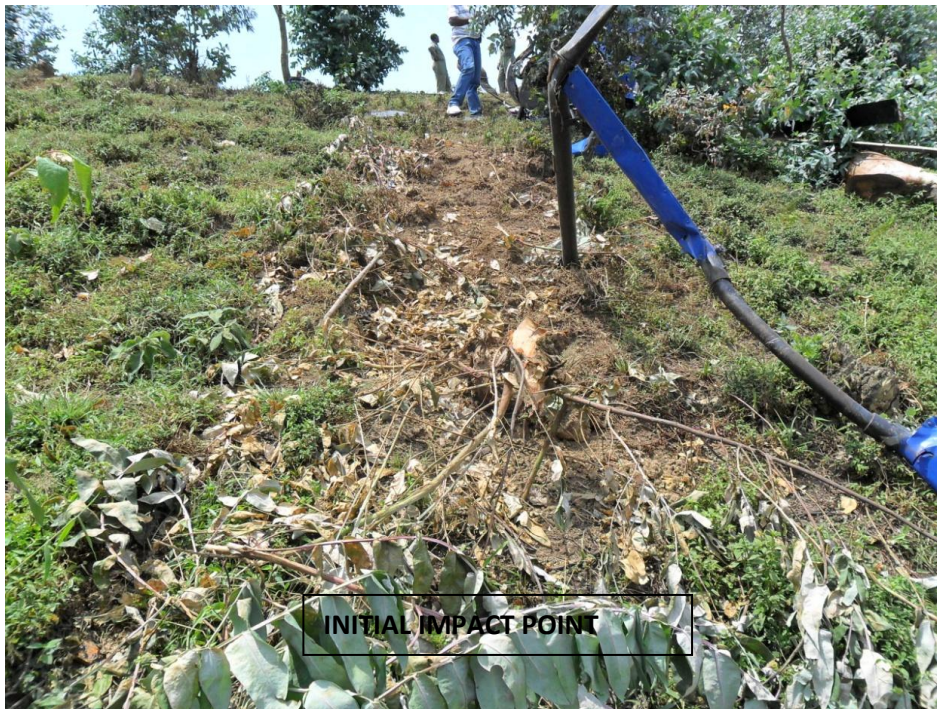
The helicopter impacted with the rising terrain first with the right landing skid, skidded on its belly up the rising terrain for approximately five meters before resting on its right side (see **Photo 4**). The initial impact point was approximately a third way from the bottom of the rising terrain.

The initial impact point showed little ground penetration and slid up the slopes of the terrain for 5 meters before resting on its right side. The skid landing gear, which had had fractured from the attach points, were located around the impact area and along the slide path.

**Photo 4.** Initial Impact point and ground skid marks (Above).

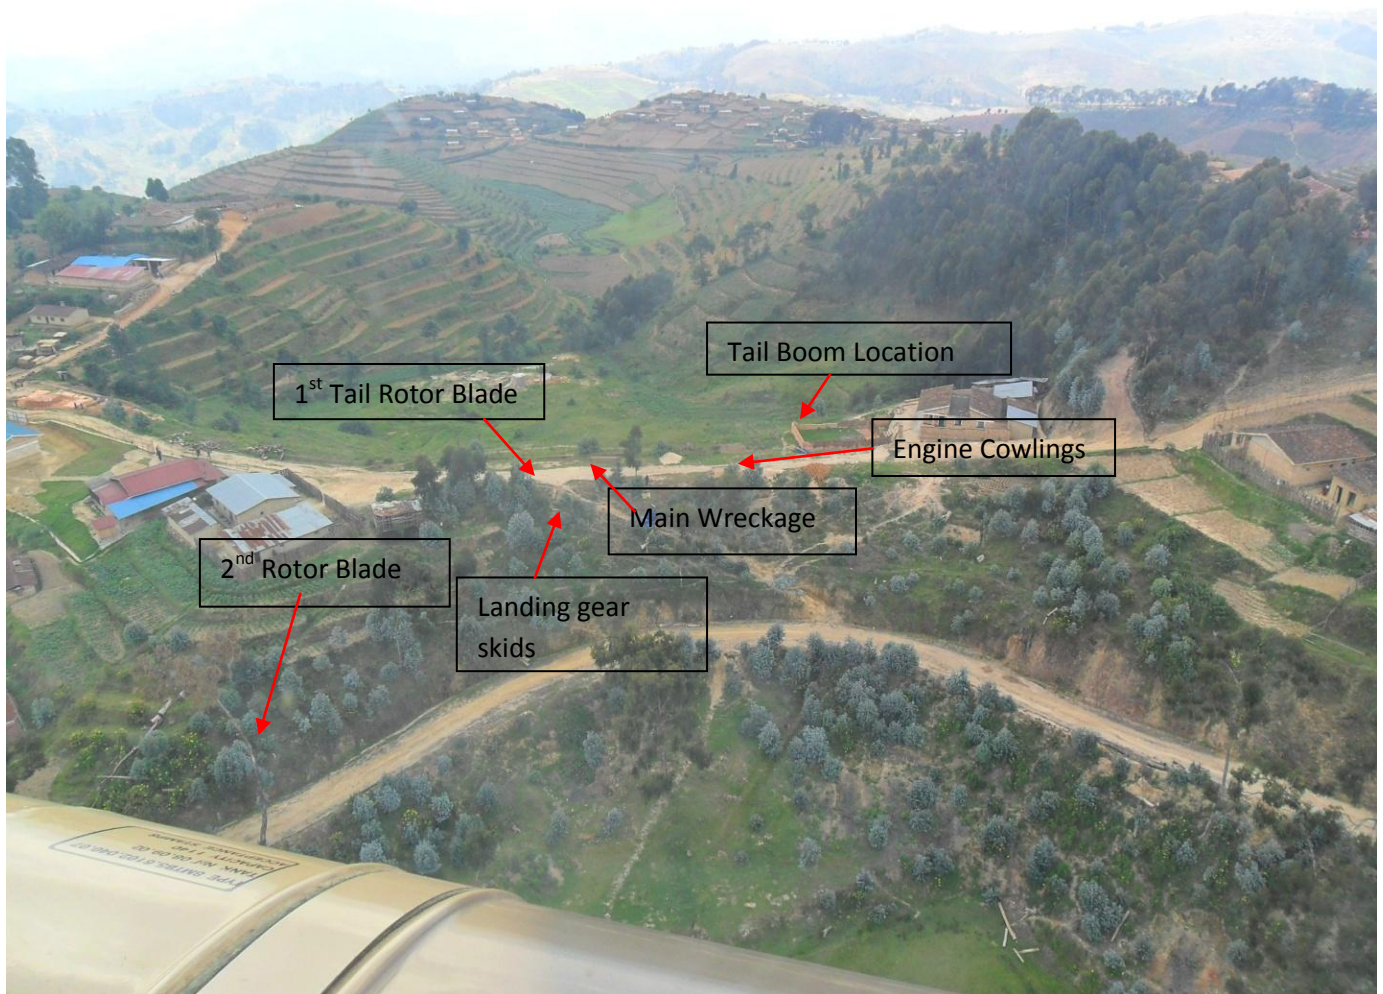
### 1.12.1.1 Aerial Photograph

Detached landing gear skids were located within the area of the initial impact point in line with the flight path. An engine cowling was located approximately 4 meters ahead of the main wreckage. The tail boom, together with the tail rotor shaft and hub, was located 25 meters and 45 degrees right of the main wreckage. Most components were still attached to or located near the main wreckage except for TRB that was found about 100 meters west of the wreckage.

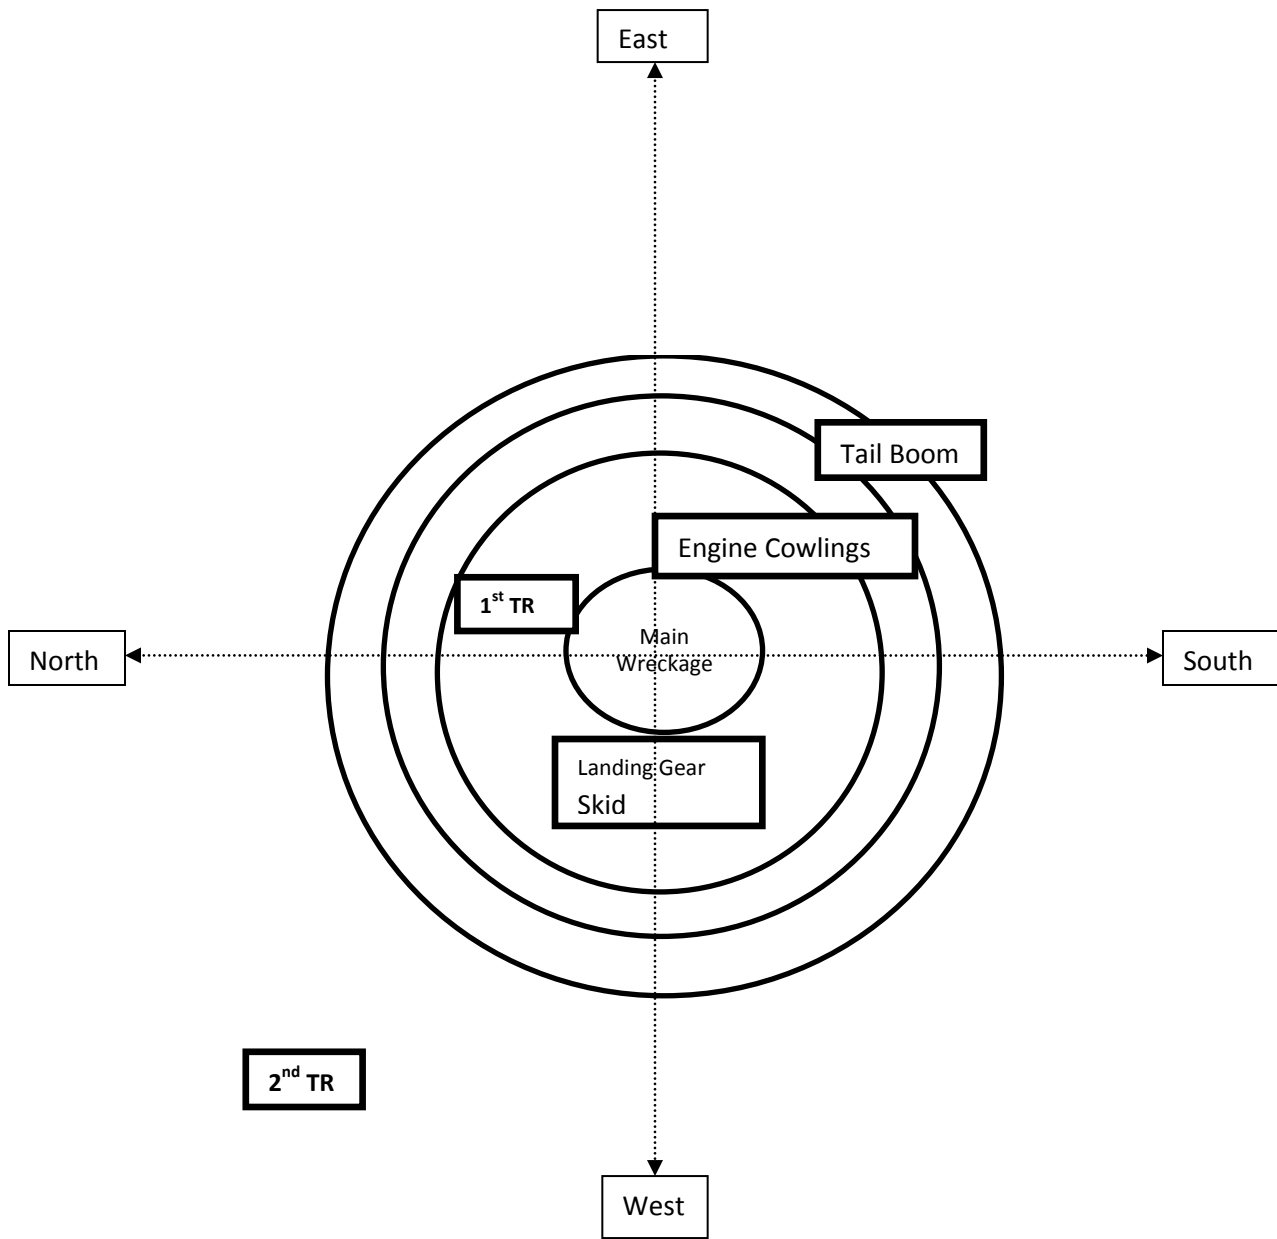
### 1.12.1.2 Scatter Diagram showing relative location of major components

The tail boom, with the  $\frac{3}{4}$  of the tail rotor shaft, vertical and horizontal stabilizers attached, was located approximately 25 meters ahead and 45 degrees right of the main wreckage. See wreckage distribution shown under 1.12.1.1 and 1.12.1.2. Examination of the lower vertical stabilizer exhibited a semi circular indentation, black and yellow paint smug on the leading edge from the root to the tip. The upper vertical stabilizer did not sustain any damage. The horizontal stabilizer sustained ground collision damage. The two tail rotor blades (TRB), which had fractured close to the blade shanks, were located one about five meters north of the main wreckage and the other about 100 meters west of the main wreckage. Examination of both tail rotor blades and tail boom fractured surfaces exhibited some bending and shear forces.
